**INTEGRATION OF DAYLIGHT IN SCHOOLS AND  
KINDERGARTENS**

**MATEJ KOBAV et al.**

Proceedings  
of the  
29th CIE SESSION  
Washington D.C., USA, June 14 – 22, 2019  
(DOI 10.25039/x46.2019)

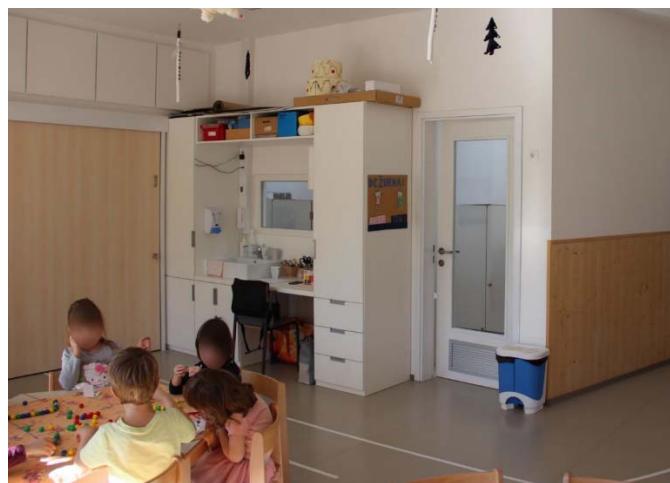
**Figure 1 – View from activity room towards bathroom**

Bathrooms are usually designed as secondary premises in view of perceived daylight and because of that they are usually located inside the buildings without any daylight. This designs' mentality was also used initially in case of this kindergarten and so there was no direct daylight penetrating into the bathrooms. In the initial design only a small amount of daylight was penetrating to the bathrooms through glass door which lead from the activity room to the bathroom and through small window between activity room and the bathroom (Figure 1).

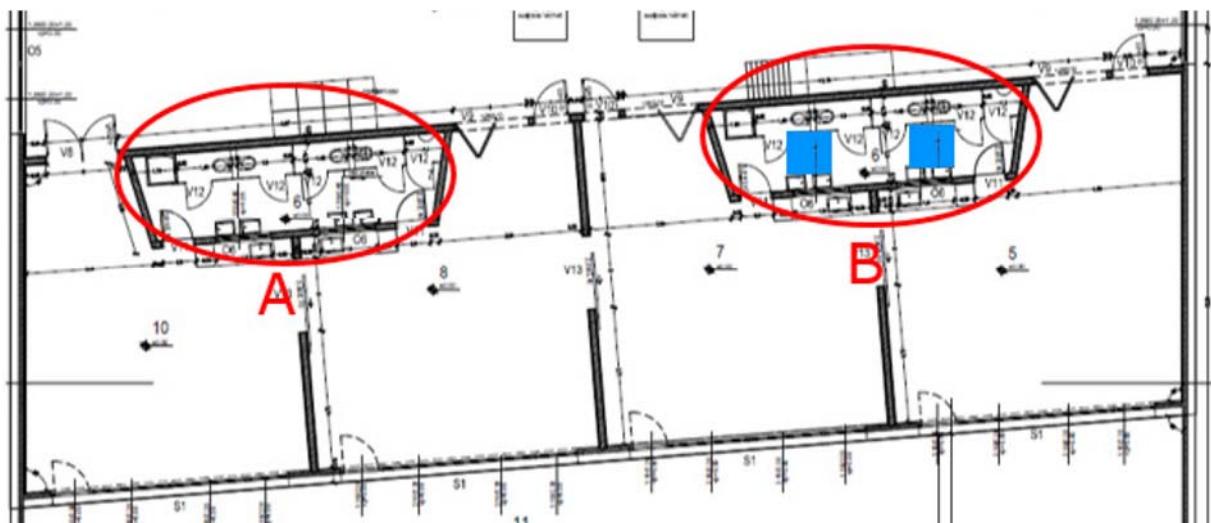
**Figure 2 – Floorplan of activity rooms with two bathrooms (A-without roof windows, B-with two roof windows)**

Luckily this kindergarten has only ground floor and because of that was possible to install roof windows in practically all premises where there was not enough daylight. To investigate the influence of daylight penetrated through the roof, we analysed two bathrooms which were same in a view of floorplan and furniture. The first bathroom (Figure 2, A) was practically without any daylight and in the second one (Figure 2, B) daylight penetration was designed with appropriate software and two large fixed flat roof windows were installed.

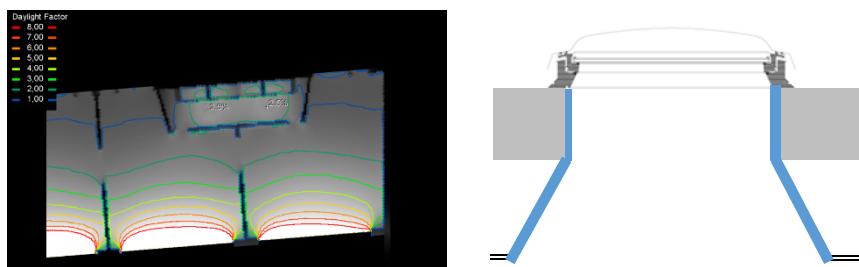
**Figure 3 – DF analyses with daylight opening 100 x 100 cm with open linings in the height of the lowered ceiling**

We analyzed two possible dimensions of horizontal openings, 100 x 100 cm (Figure 3) and 120 x 120 cm (Figure 4), simulated with daylight factor (DF). In both cases we predicted open linings. The result shows a DF of 2,5% in most of the area for dimension 100 x 100 cm and 4,3% DF for dimension 120 x 120 cm.

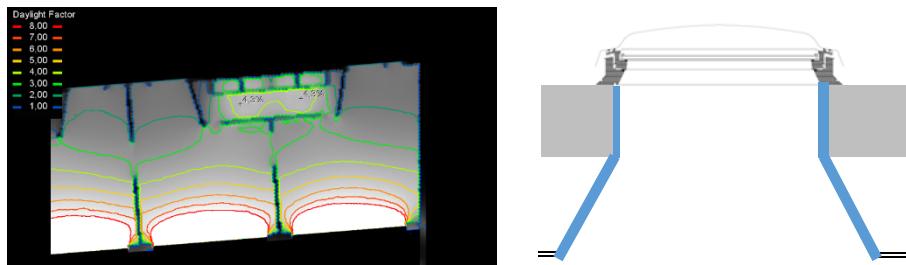
**Figure 4 – DF analyses with daylight opening 120 x 120 cm with open linings in the height of the lowered ceiling**

Differences in DF lead us to decision to choose daylight opening 120 x 120 cm. The goal was that daylight is the primary source of light during the daylit hours, without a need for artificial light to be switched on unless early in the mornings and late in the afternoons. A room with an average DF above 2% will assure that room will not look dull (CIBSE, 1999).

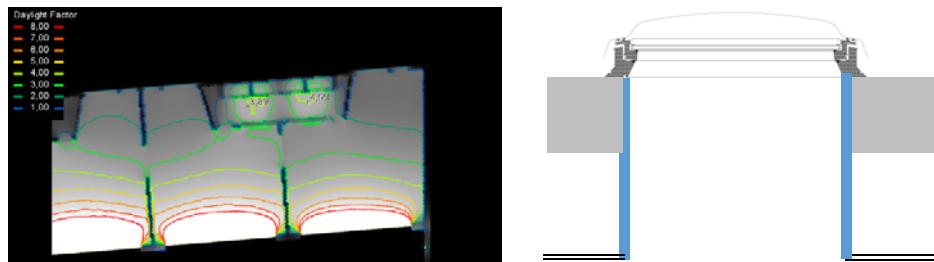
**Figure 5 – DF analyses with daylight opening 120 x 120 cm with vertical linings in the height of the lowered ceiling**

Design of lining construction has an impact on daylight conditions, what is seen from Figure 5. With vertical lining DF drops from 4,3 % to 3,8 %.

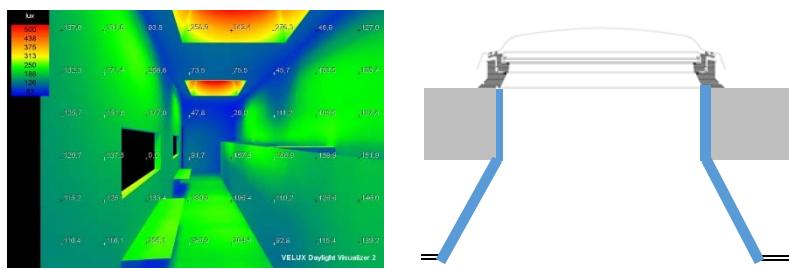
**Figure 6 – Illuminance levels in range above 200 lx on the surfaces of washbasins.**

We analysed also Illuminance levels to be able to confirm that illumination of the surfaces in the area of washbasins used during the day (washing hands after using toilets, before each meal, after art activities like painting with water colors etc.) exceeds at least 100 lx (Figure 4a). Because in practice construction of the linings is most often simplified due to the space needed for installations in the ceiling, we analyzed also the illuminance levels in case of vertical linings. In both cases washbasin surfaces exceeds 100 lx.

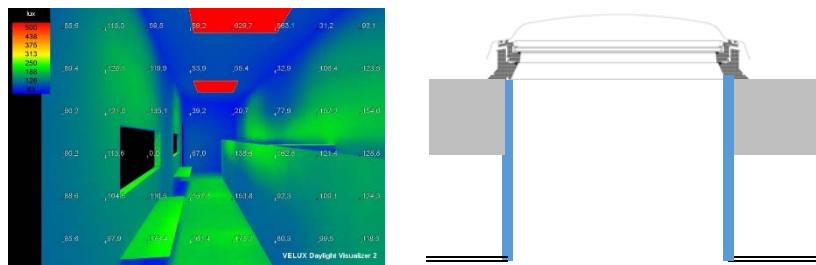
**Figure 7 – Illuminance levels in range above 100 lx on the surfaces of washbasins.**

When flat roof windows were installed, the linings were made in vertical shape as shown in Figure 7.

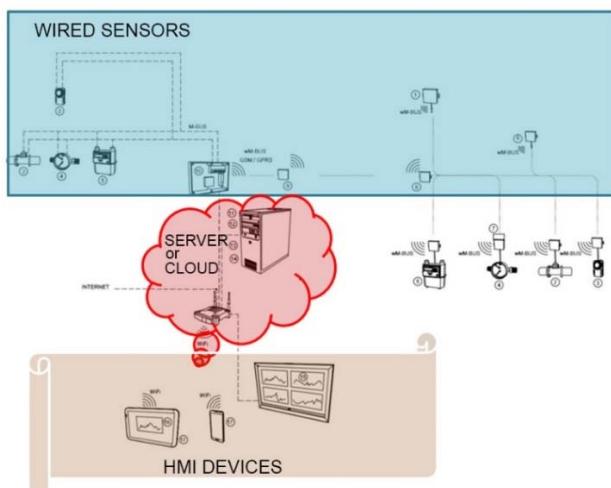
**Figure 8 – Cloud based monitoring**

Energy monitoring in this kindergarten was installed to compare results from models with real measurements from a living building. All measurements were directly uploaded to a cloud server and web based interface was used to view data in real time (Figure 8). The user interface is possible to display hourly data for energy consumption for the whole kindergarten and for some consumers with higher powers, temperature of all playrooms, consumption of HVAC system. Beside energy as a pilot study, we were also monitoring illuminance values in two bathrooms. Each bathroom was equipped with an illuminance meter. Illuminance meters were mounted on the wall, facing activity room, at the height 1.8 m. Illuminance meters measured vertical illuminance and were connected to the measuring system. Since we were interested in more frequent measurements, illuminance values were collected every 4 minutes; all other values were collected every 60 minutes. All collected data are available at: [http://www.energija-rr.si/view\\_locations\\_graphs/index.php?id\\_location=116&id\\_location\\_slide\\_site=923](http://www.energija-rr.si/view_locations_graphs/index.php?id_location=116&id_location_slide_site=923)

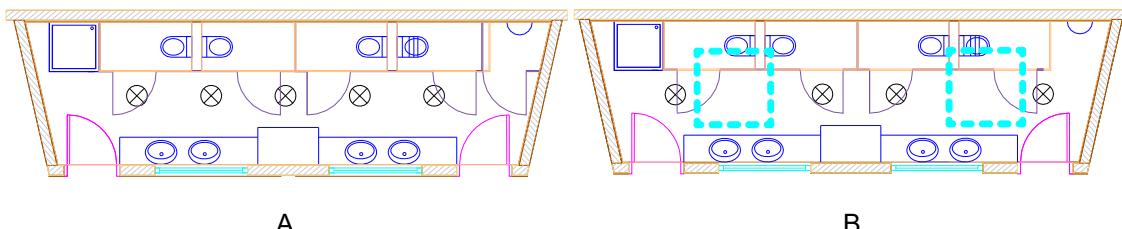
**Figure 9 – Floorplan with luminaires of both bathrooms (A-without roof windows, B-with two roof windows)**

In both bathrooms, LED luminaires (Schrack Lumo Round 24 W) with approximately 1500 lm and with correlated colour temperature 4000 K were installed. In a bathroom A (without roof windows), five luminaires were installed and in the bathroom B (with roof windows) only four luminaires were installed because there was a lack of space in the ceiling (Figure 9). In a bathroom A in accordance with technical note [2] a presence sensor was installed, in bathroom B beside a presence sensor also a secondary illuminance sensor was installed. Electrical installation was arranged in a way that luminaires in the bathroom B were switched on only if daylight illuminance dropped below 500 lx and there was a person in the bathroom.

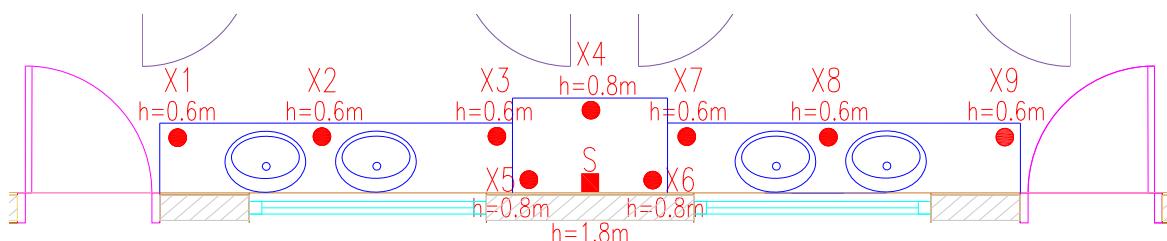
**Figure 10 – Points with added height, where illuminance levels were carried out (circle – one-time measurements, square – long term measurement)**

One-time measurements were carried out on January 29<sup>th</sup> 2018. In each bathroom, nine points were selected where horizontal illuminance measurements were performed (Figure 10). Additional point S was selected at the sensor to compare it with long-term measurements.

Points were selected on surfaces, where the most important visual tasks in bathroom are carried out: at height 0.6 m on the desk around basins and in the middle of the bathroom at 0.8 m on the table, where diapers are changed. Measurements are listed in table 1. A man can see that illuminance values in bathroom with roof windows are more than ten times higher when compared with the values in the bathroom without roof windows. The average factor is almost 13. In the last row of the Table 1 also illuminance values from SCADA (long term Figure 11) were added for comparison.

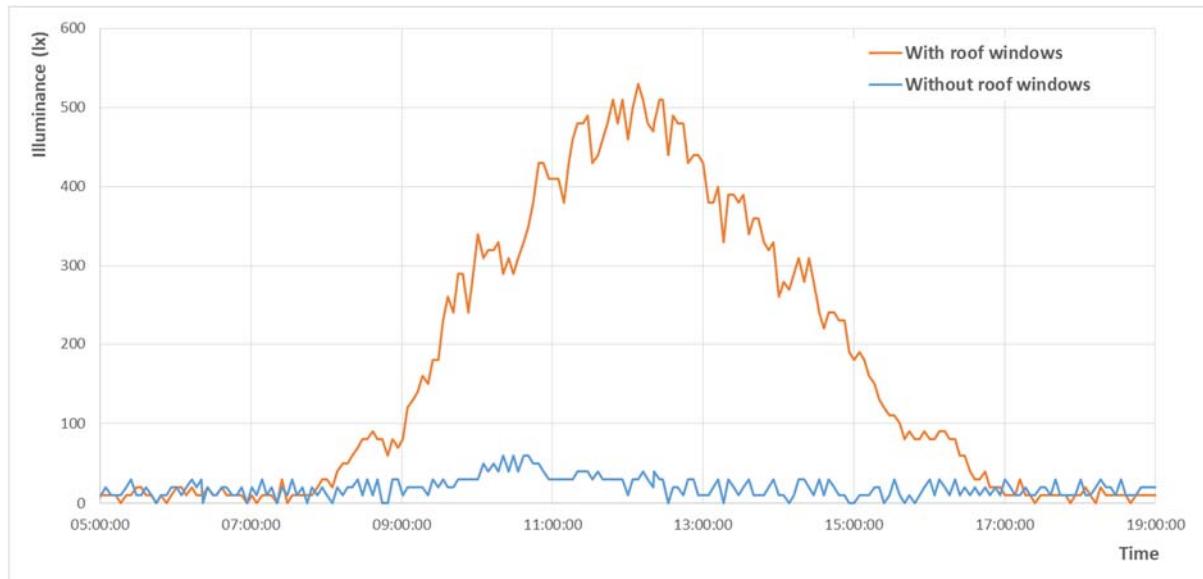
**Figure 11 – Illuminance values for the bathroom with and without roof windows for the day (27.1.2018), when one-time measurements were carried out (SCADA values).**

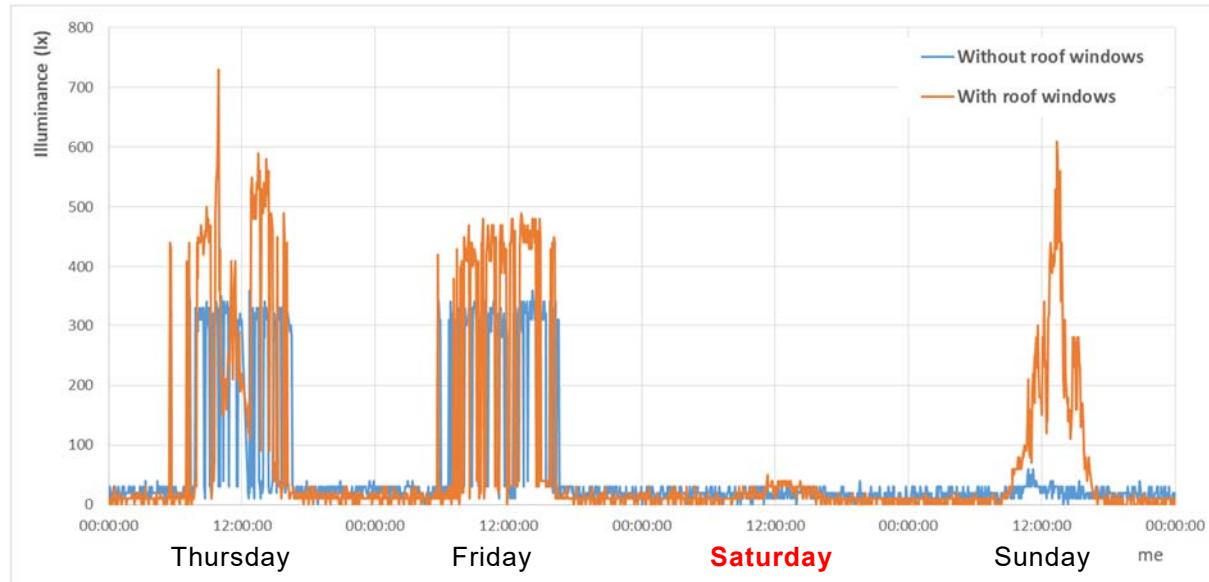
**Figure 12 – Illuminance values for bathrooms with and without roof windows for four days with one totally overcast day in winter (Saturday, 3.2.2018)**

During winter months and cloudy skies daylight is not sufficient during most of the day. In Figure 12 we show illuminance values for both bathrooms for the period from February 1<sup>st</sup> 2018 to February 4<sup>th</sup> 2018. Because also artificial lighting is switching on during working days, we should pay attention to Saturday, when kindergarten is closed and artificial lighting is off. A man can see that illuminance levels also in a bathroom with roof windows are below 50 lx all day long. Therefore, during winter months and overcast skies there are no energy savings.

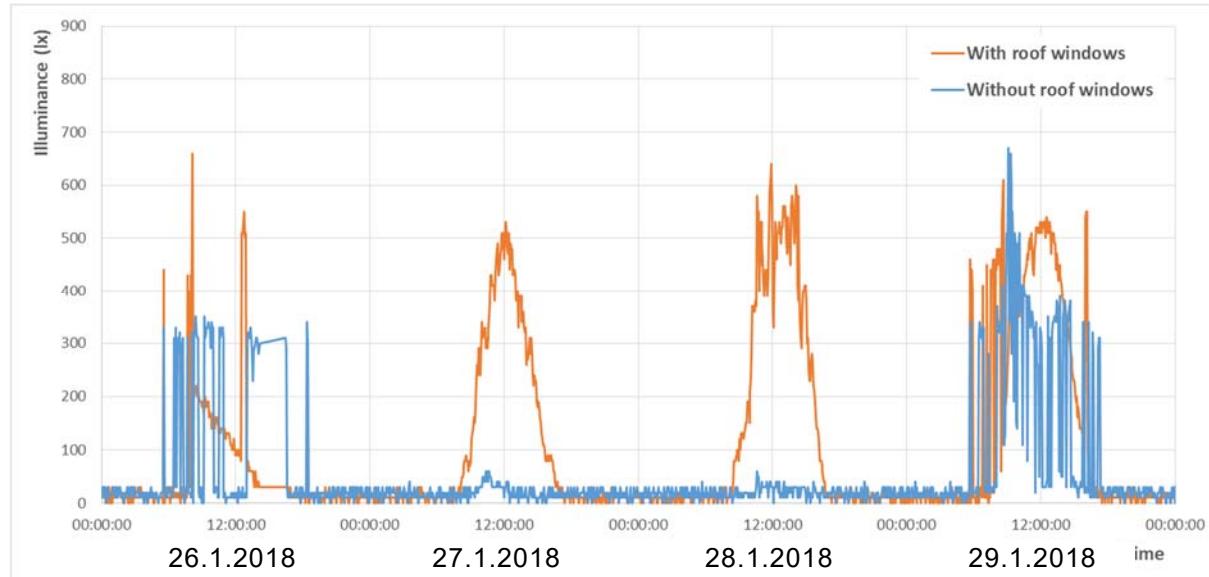
**Figure 13 – Illuminance values for bathrooms with and without roof windows for four days with one more or less clear day in winter (Saturday, 27.1.2018)**

On sunny days - also in winter - the illuminance in a daylit bathroom between 9 AM and 4 PM opening hours is maintained above 100 lx and above 300 lx between 10:30 AM and 2 PM. If the skies are sunny, than artificial lighting is needed in winter months only in the morning and in the afternoon (Figure 13).

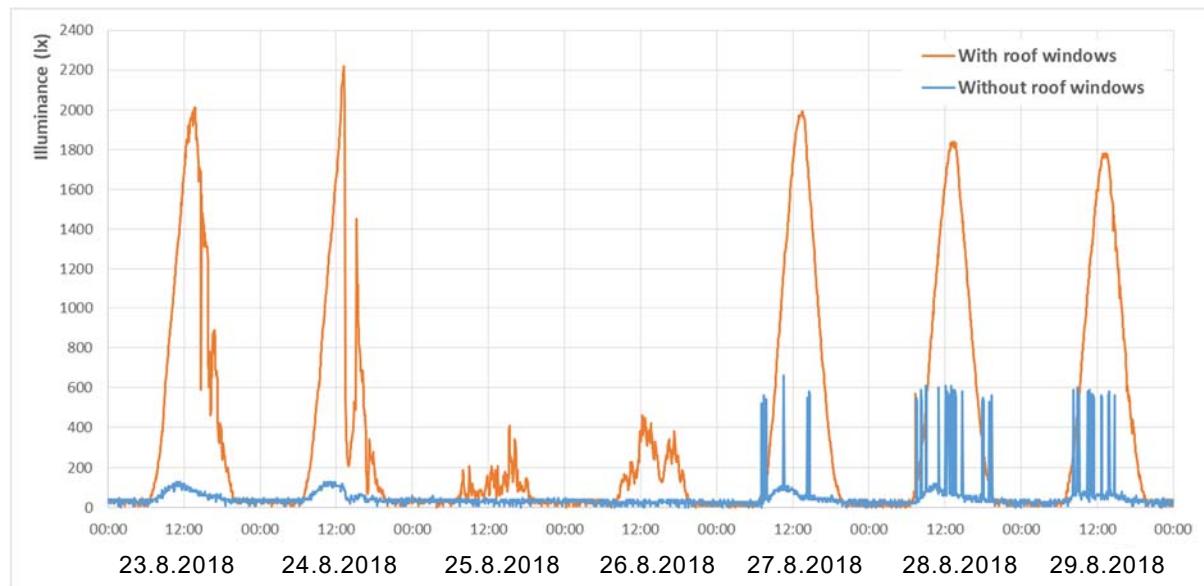
**Figure 14 – Illuminance values for bathrooms with and without roof windows for one week with clear and overcast skies in summer**

In summer months, illuminance in daylit bathroom is much higher when compared with the bathroom without roof windows. With sunny skies, it reaches up to 2.500 lx (Figure 14). With

extremely cloudy skies, which are rare in summer, illuminance is maintained above 150 lx between 8 AM and 6 PM.

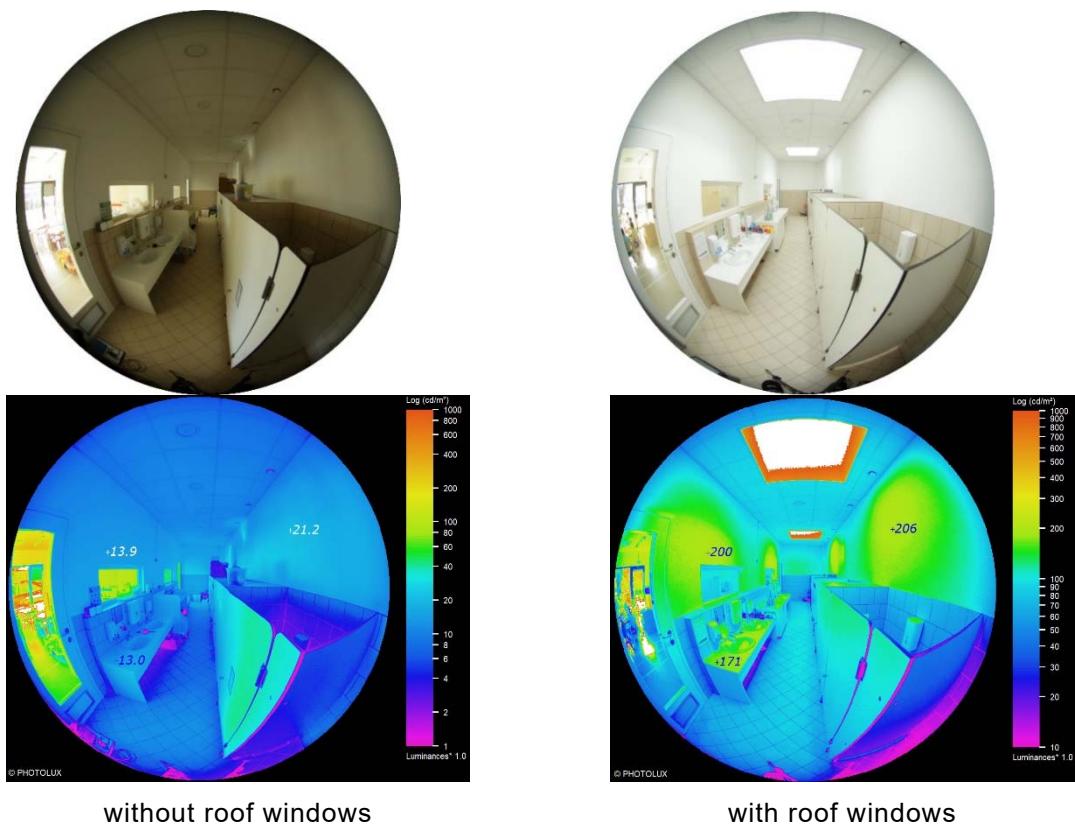
**Figure 15 – Luminance maps for bathrooms without and with roof windows**

Luminance measurements were carried out at the same time as one-time illuminance measurements; on January 29<sup>th</sup> 2018 at 1 PM. Sky was clear. We used calibrated digital camera Canon EOS 50D and Sigma Fish-eye lens for taking several images with different exposure values and software Photolux for creating luminance maps. Luminance maps are shown in Figure 15. As a man can see from the luminance maps in Figure 15, the values of luminances in bathroom with roof windows are approximately 10 times higher than the ones in a bathroom without roof windows. The ratio is the same as for illuminance values.
